Subject: results of test according ICAO Doc 9157 Aerodrome Design Manual part 6 – Frangibility 483km/h”

Test protocol: ICAO Doc 9157 part 6 §5.2.3.
Location: Achtseweg Zuid 153-C, Eindhoven, The Netherlands
Test date: 8th of August 2023

The sample provided was a runway guidance sign with the following characteristics:

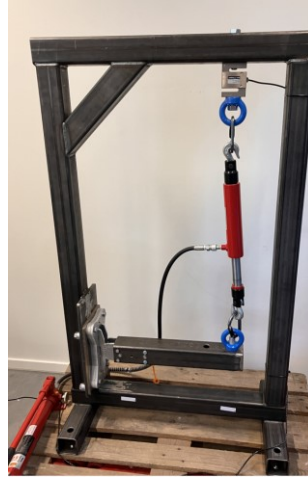
During the test the break coupling was mounted horizontally in a test rig and loaded with a force equal to the specified wind loads from ICAO Doc 9157 part 6 §5.2.3.

Figure 1 - Test rig with means to apply forces
